SPACECRAFT ELECTRICAL CONNECTOR SELECTION AND APPLICATION PROCESSES

An overview of an internal assessment of NASA's processes on electrical connector selection and application as well as derived lessons learned.

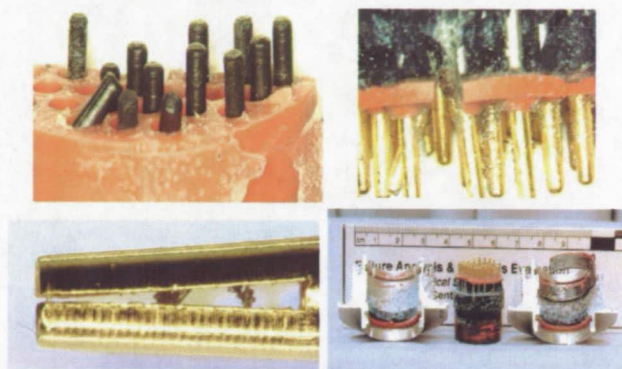
For the wing feed-through connector the failure mode was intermittent data drop-out of the wing feed-through a MIL-C-

38999 series 2 connector. The root cause was silicone contamination on the feed-through connector pins and sockets. The silicone contamination created a high resistance, resulting in an intermittent condition (Figure 10).

Consequently, a GIDEP Alert was generated. The connector vendor confirmed the origin of the silicone to be a result of a silicone bath the feed-through connectors were exposed to during manufacturing. Corrective actions were to add a spray bonded interfacial seal process and require a continuity check prior to use.

Figure 10. Wing Feed-through Connector Contamination

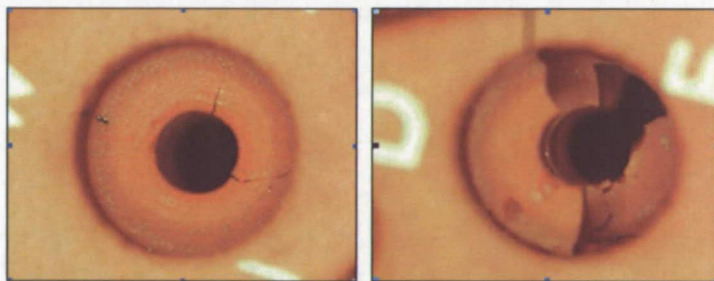
Numerous connectors have exhibited grommet damage during contact extraction/insertion, which requires connector replacement (Figure 11). Preliminary analysis found several possible causes including seal gland design, grommet elasticity, grommet hardness, and grommet material. Limiting reuse of connector extraction tools is also expected to reduce grommet damage.

Figure 11. Torn grommet seal examples

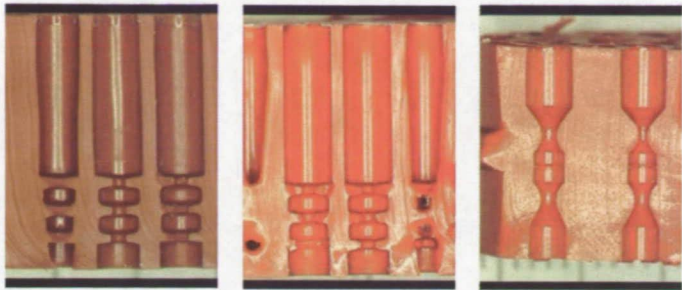
Analysis shows that the sharper seal design, coupled with the lower elasticity of the material may be responsible for the poor performance of the middle grommet design (see Figure 12). This grommet design was also most likely to tear during insertion and extraction of contacts.

Figure 12. Cross-sections of three manufacturer's grommet seals. The middle design was most likely to tear

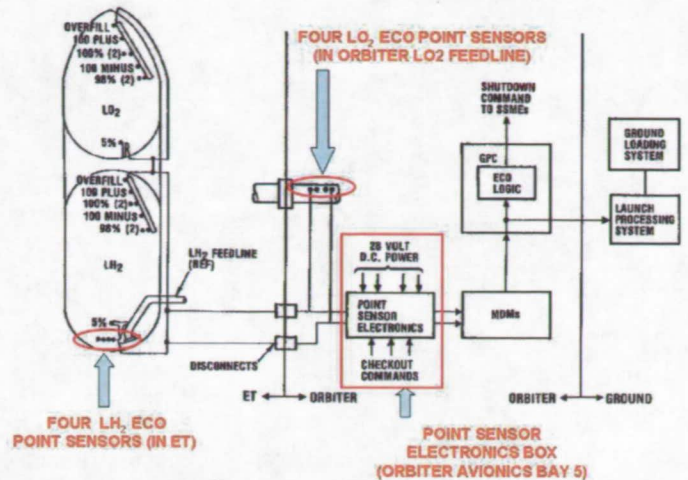
The sensor system that has experienced anomalous readings is the Liquid Hydrogen (LH2) section of the External Tank (ET). The failure could be the sensors, the wiring harness, one of several connectors or in the avionics box which monitors the sensor resistances. Resistance of the sensors is monitored through the wiring and connectors. The avionics sensor box in the orbiter sends data signals to the orbiter's onboard computer system. Sensor wires pass through a feed through connector in the side of the tank. The external cables run up the external tank vertical strut to the LH2 ET/Orbiter interface. There are four ECO sensors in the LH2 tank; mounted approximately four feet from the bottom of the tank. Similar ECO sensors are also located on the liquid oxygen tank. A schematic of the system is given in Figure 13.

Figure 13. Overall schematic of the Engine Cutoff (ECO) system. The problem was isolated to the liquid hydrogen feed-through connector.

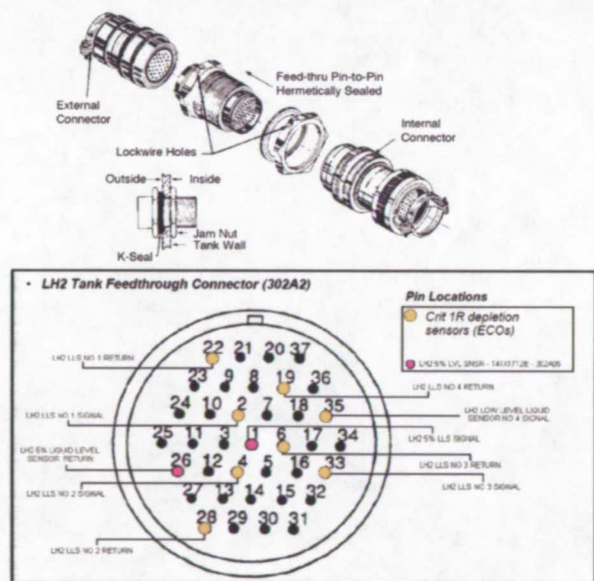
When immersed in LH2 the sensor is "wet" and has a low resistance. Resistance at the avionics box includes the wiring and a "wet" sensor reading would be about 14 ohms. The sensor is "dry" when not immersed in LH2 and reads above 50 ohms at the avionics box. The anomalous condition prior to several shuttle launches was a "dry" reading when the LH2 tank was full. This indicates the sensor had failed open or there was an open in the wiring system. During the investigation of the unsuccessful Dec 2007 launch attempt the avionics box was ruled out as the source of the failure. Extensive fault isolation and ground testing confirmed the open occurred at the LH2 external tank feed-through connector (see Figure 14).

Figure 14. ET Liquid Hydrogen Cryogenic Feed-through

and Mating Connectors and Pin Assignments

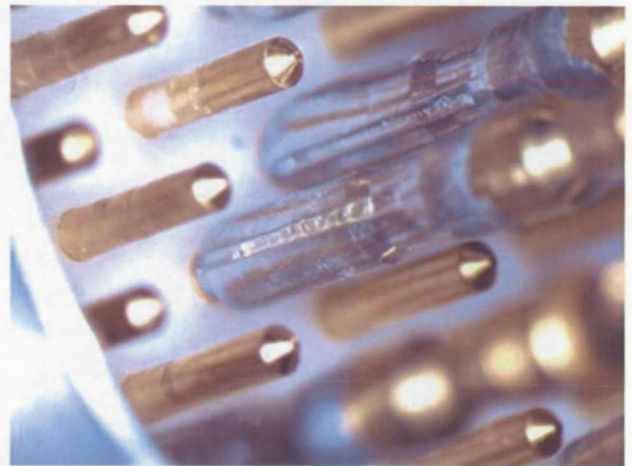
Ground testing also revealed the pin and socket contacts would electrically open when the assembly was exposed to LH2. LH2 is approximately -423°F (-253°C) which is well below the operating capability of most materials. Removing the LH2 allowed the connector to warm up and continuity was re-established between the pin and socket contacts. Materials analysis revealed non-conductive contamination on the pin and sockets in the form of a grease and silicone oil (see Figure 15). It is also theorized that lateral pin movement occurs when the connector is exposed to LH2; reducing the contact area between the socket and pin. The failure cause was a combination of events; foremost being the feed-through connector was not designed to withstand LH2 cryogenic temperatures. Testing showed that a thin layer of frozen air/moisture forms on the pin/socket interfaces and pin movement occurs when the connector is exposed to LH2 (see Figure 15). Several years earlier the socket contact was also changed from a four tine to a two tine design. This made the socket/pin connection more susceptible to an open condition. In addition, non-conductive contamination reached the pins and sockets. Silicon oil contamination was most likely introduced during the connector manufacturing process and Krytox[®] grease contamination during a procedure that applied grease to connector faces to improve the seal between the interfaces (Figure 15).

Krytox[®] grease was found on the pin and socket

Silicone oil was found on the hard insert connector

Figure 15. Analysis revealed grease and silicone oil contamination on the feed-through connector sockets and pins. At LH2 temperature a frozen layer of air forms; separating the pin and socket and resulting in an open condition.
